*Detecting Failures Using Oil Analysis**

(Case history provided by National Tribology Services)

Equipment: Induced Draft Fan

Component: 500 HP Motor

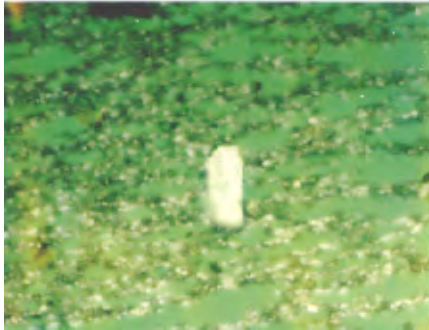
Fig.1 Photomicrograph of a babbitt metal. Particle size 45 μ m.
Magnification 500X

The RFS analytical results prompted ferrographic analysis to be performed on this sample. The ferrogram indicated light amount of fine ferrous wear particles and moderate amount of severe sliding wear particles at the entry point of the ferrogram. The severe ferrous wear particles have a particle diameter in the range of 15 to 35 μ m. The ferrogram also indicated nonferrous wear particles all along the ferrogram. Most of the nonferrous wear particles are babbitt metal particle and have a particle diameter in the range of 20 to 45 μ m. Some of these babbitt metals have oxidized surface due to the fact that Pb/Sn alloys are extremely susceptible to oxidation at temperatures that are considered low in ferrous metallurgy.

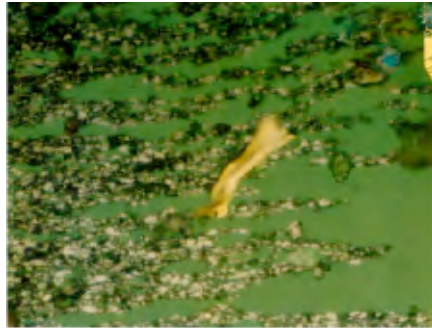
Fig.3 Photomicrograph indicating an isolated copper particle.
Magnification 500X

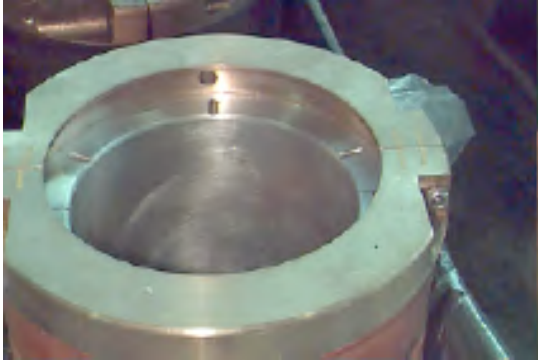
New Bearing

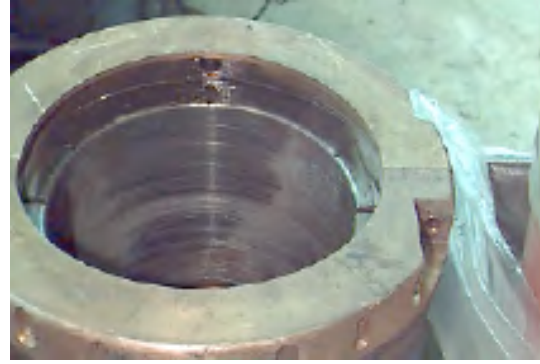
As expected and recommended, inspection of the bearing indicated wiping of the lining. The babbitt lining was clearly smeared by wiping and also was removed from the surface of the bearing. The extent of wiping damage as indicated in the picture is higher at the end side of the bearing.

Wiped Bearing

Wiping can result due to loss of lubricant, overload and misalignment of the bearing. Lack of balance of the shaft ,for example, due to thermally bent shaft could cause the kind of wiping indicated on the bearing.

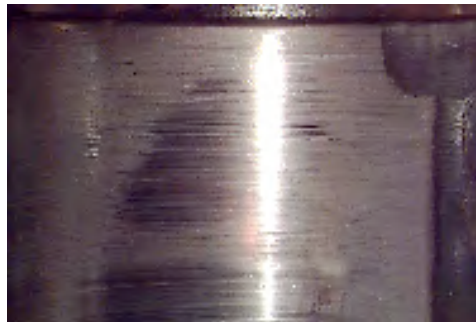
Close up of the wiped bearing
