A-RFS CASE HISTORY

Detecting Damage to Bearing Surfaces In A F110-GE-100 Gas Turbine Engine

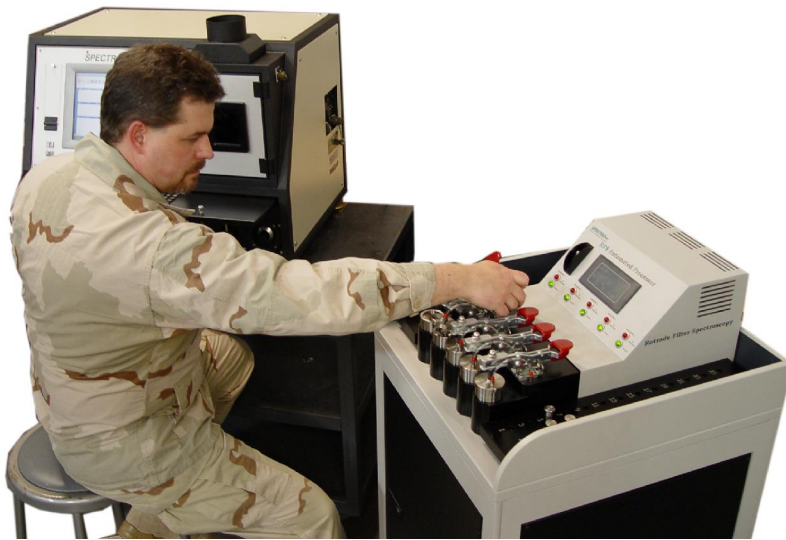
Figure 1. A-RFS Device in Operation

By concentrating 5 ml of oil sample (50 times what is analyzed by conventional AES analysis), all particle debris (metallic and non-metallic) becomes trapped within the outer circumference of the graphite filter electrode. This process eliminates the major limitations (gravity, oil, resonance time) of conventional AES analysis. Efficient vaporization of all particles (large and small) is achieved using the total energy produced by the excitation source to reach vaporization temperatures in excess of 5,600 degrees Celsius. This is particularly important when alloy identification (such as M50) is necessary and damaging contaminants, such as silicon containing particles are present. When applied to aviation gas turbine engine oil analysis, the A-RFS can enhance the effectiveness of AES to detect the harmful effects of lubricant contamination and the subsequent bearing damage. The A-RFS is shown in operation next to the arc emission spectrometer in Figure 1.

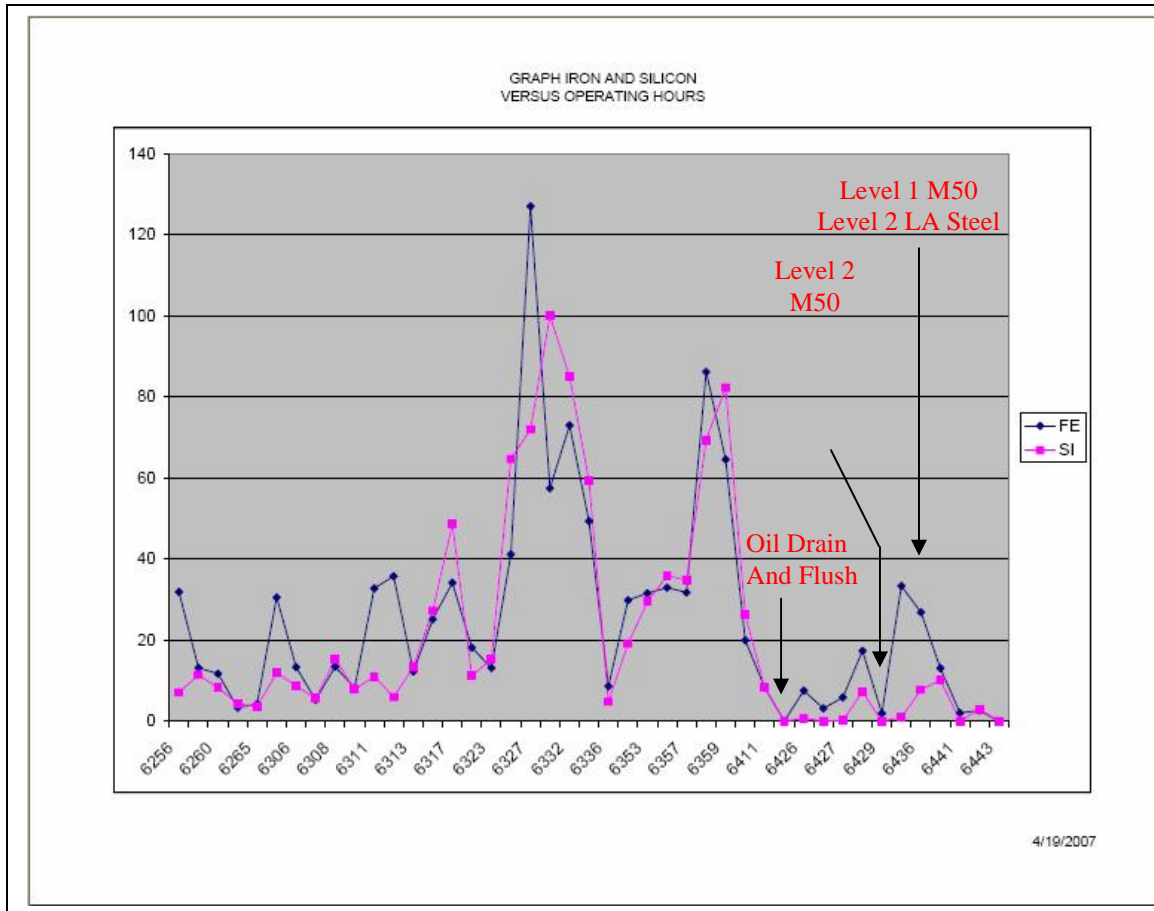
Figure 2. A-RFS History of Iron and Silicon from F110-GE-100 Engine

The following graph illustrates the change in trend starting at 6315 hours, after which abrasive silicon contamination apparently entered the lubricant system. There is noticeable correlation between the abrasive silicon contaminant and the iron concentration. Notations have been added to the A-RFS Iron and Silicon graph to aid in establishing correlation of the A-RFS and SEM/EDX analysis.

A quick review of this data, particularly for the elements iron and silicon, reveal abnormally high concentrations beginning at hour (T-HRS) 6325 and continuing through hour 6361. In addition, elements such as chromium, vanadium and nickel and molybdenum are also present and in tandem with iron and silicon. These elements are part of the M50 and M50 NiL chemistry.

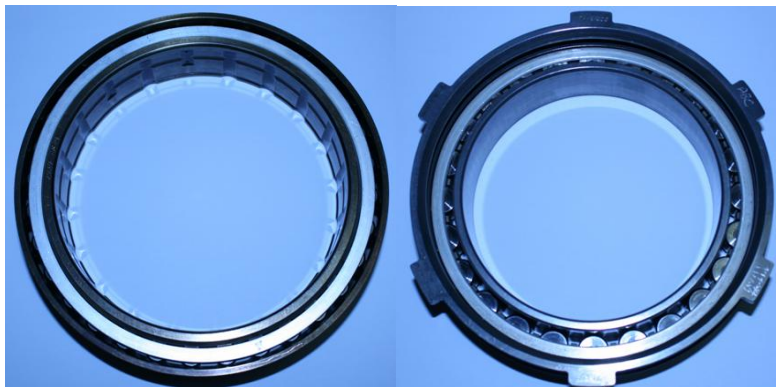
Figure 3. #4 and #5 Bearings Removed from F110-GE-100 Engine

This engine was taken out of service on or about 6411 operating hours. In addition to other components, the #4 (M50 NiL) and #5 (M50) bearings were replaced. Figure 3 below are photographs of the bearings removed during maintenance.

Visual inspection of these bearings under magnification confirmed that surface damage caused by silicon particulate debris had occurred, as well as scoring of the rolling elements.

Post maintenance engine records indicate that the gearbox, hydraulic pump, auxiliary fuel pump, lube and scavenge pump plus the #4 and #5 bearings were initially replaced. A thorough analysis of the #4 and #5 bearings confirmed extensive surface damage. After repair, the engine was run in a test cell where it continued to exceed SEM/EDX guidelines. The #1, #2, and #3 bearings were all replaced and returned back to the test cell. After several drains and flushing of the lubricant through the engine, it was returned to service.
