A-RFS CASE HISTORY

Averting Catastrophic Failure of a Main Transmission in a US Army Helicopter

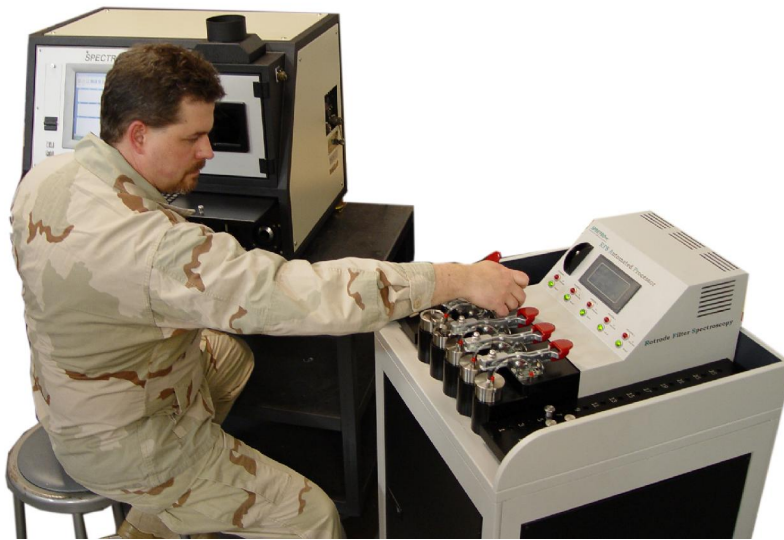
Figure 1. A-RFS Device in Operation

By concentrating 5 ml of oil sample (fifty times the volume analyzed by conventional RDE/AES analysis), all particle debris (metallic and non-metallic) becomes trapped within the outer circumference of the graphite filter electrode. This process eliminates the major limitations (gravity, oil, resonance time) of conventional RDE/AES analysis. Efficient vaporization of all particles (large and small) is achieved using the total energy produced by the excitation source to reach vaporization temperatures in excess of 5,600 degrees Celsius. This is particularly important when alloy identification (such as M50) is necessary and damaging contaminants, such as silicon containing particles are present. When applied to helicopter engines, transmissions and gearboxes, rotrode filter (RF) analysis can enhance the effectiveness of AES to detect the harmful effects of lubricant contamination and component damage. The A-RFS is shown in operation next to the atomic emission spectrometer in Figure 1.

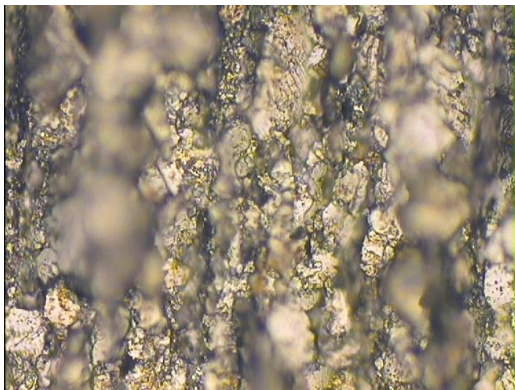
Figure 5. Ferrogram Slide #1

A ferrogram is made by diluting an oil sample to reduce its viscosity. The sample then flows from one end of a special microscope slide to the opposite end while being subjected to a powerful magnetic field. The larger wear particles become trapped quickly whereas the smaller particles, with less mass, travel further along the slide before they are trapped by the magnetic field. As a result, the ferrous debris becomes separated by particle size thus allowing microscopic inspection to be performed. Figures 5 and 6 are ferrogram screen images of the wear metal debris from sample number 0534A.

As a result of a thorough multiple analytical assay of sample 0345A, the laboratory submitted the following maintenance recommendation:

Excessive Rubbing Wear
Excessive Cutting Wear
Excessive Sliding Wear
Exceeds NAS1638 Limits
Excessive Spalling Fatigue Wear
DO NOT FLY

Reference serviceability check from component manual and submit completed 3254-R with resample.

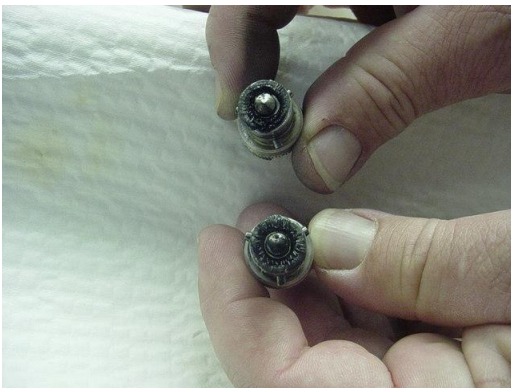
Figure 7. Defective Magnetic Chip Detectors (MCD)

Both magnetic chip detectors in the main transmission of this helicopter were defective and did not indicate imminent failure of the component. In addition, the warning lights never illuminated to show that the chip detectors had failed. This combination of diagnostic monitoring failures placed the main transmission in an unmonitored condition whereby component degradation and catastrophic failure were undetectable.

Figures 7 and 8 are photographs of the magnetic chip detectors removed from the defective main transmission illustrating the severity of wear debris generated by this malfunction.

The main transmission was removed from service and sent to depot maintenance for teardown inspection and overhaul. Post teardown and inspection records from the overhaul maintenance depot are on request.
